Battery A60 Fire Survivability Test 2 Preliminary

DOC-0306-B

1.1 Scope of this Document

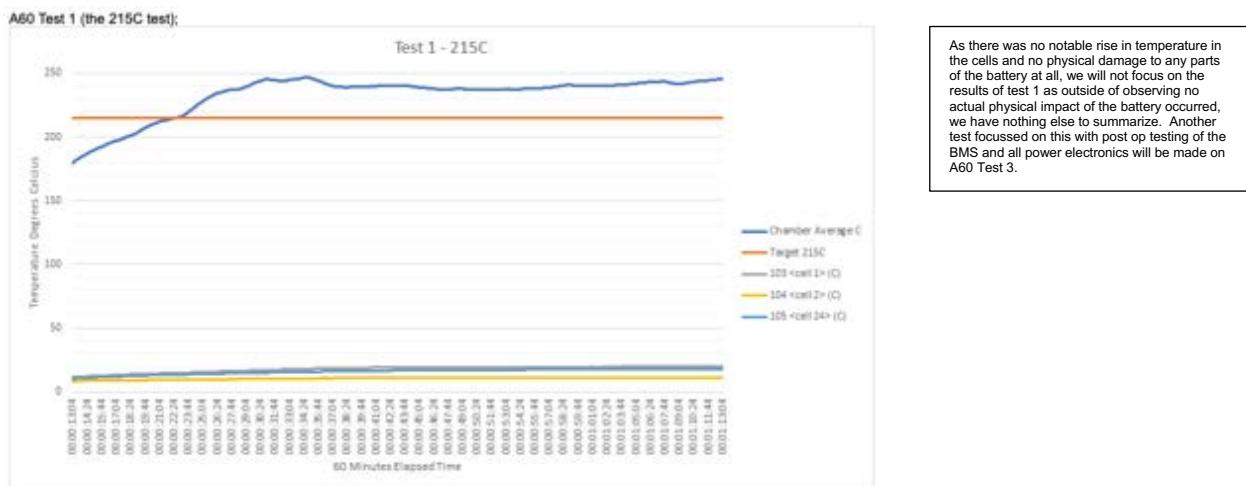
Graph of Test 1

Test 1 – 215°C for 60 minutes – A60 bulkhead maximum surface temperature

The test was completed without interruption or issue. The battery module withstood the 60-minute heat with no visual degradation externally, no leakage from the cooling system and certainly no thermal event from the cells. Cell temperature during the test never exceeded 19.7°C. Apart from a light covering of soot from the gas burners, the battery was in perfect condition. The heat during the test was brought up to and kept above 215°C over the duration of 60 minutes – it took 9 minutes and 35 seconds to get the temperature over 215°C, it was kept between 230°C and 250°C for the remaining test period. As the battery was in such good condition after Test 1, it was immediately used for the higher temperature Test 2 – the battery was not stripped down between tests.

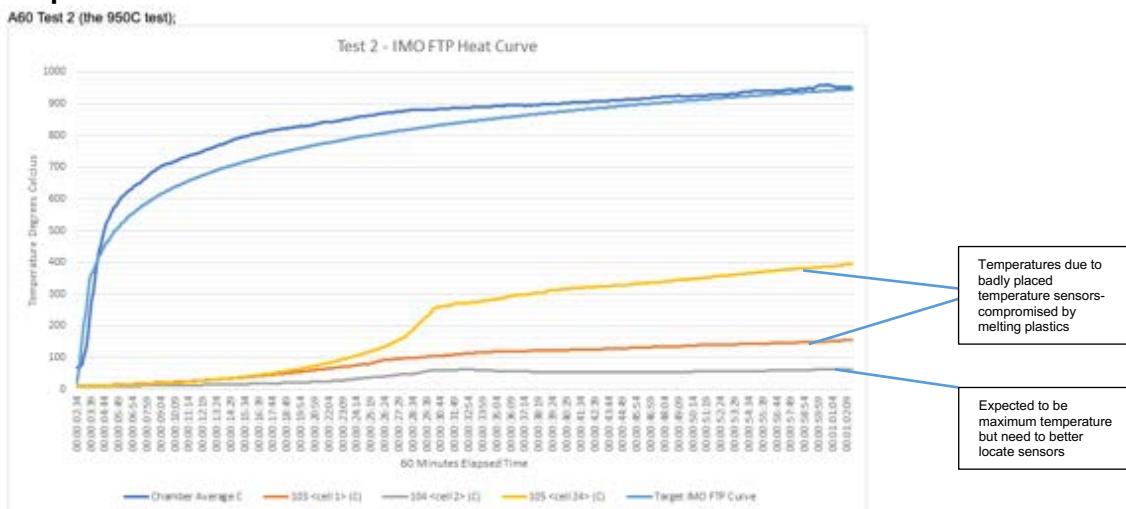
Graph of Test 2

Test 2 – IMO FTP Code Fire Heat Curve (up to 950°C) – A60 heat survivability

This test was also completed without interruption or issue. The heat rise was controlled to follow the IMO FTP Code heat formula, starting at 20°C and reaching 945°C – at most times the test heat was higher than this, reaching a maximum of 960°C towards the end. The plastic fittings within the battery were melted and destroyed by the heat, but the main battery core containing the cells and the cooling system was completely intact. During the test none of the lithium cells within the battery module went into thermal runaway – cells #1 temperature was recorded up to 154°C, with cell #24 reaching 396°C, however on examination of the cells, we have determined that this was due to melted plastics within the battery module reaching and affecting the thermocouple sensor. Cell #2 recorded a more realistic maximum temperature of 64°C after 60 minutes. We still have to do another test to validate the actual test of the cells with more reliably located sensors, but our conclusion of physical examination is that the temperature of Cell #2 is likely to be a maximum of all of the cells. There is no way the cells would have survived either a 154°C or a 396°C temperature without bloating and failure occurring, and none of the cells on inspection were damaged significantly physically at all. After cooling for 24 hours, the battery was dis-assembled, and the cells closely examined – all were intact with no thermal event evident although pin holes and minor gas release was suspected on cells #1 and #24. Cell #2 still recorded a voltage reading.

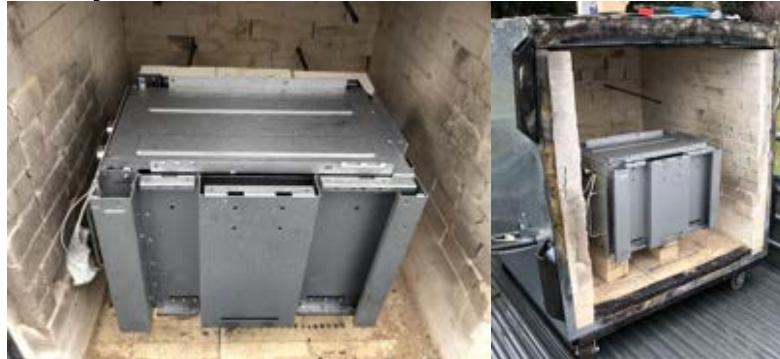
Battery in Rack mounted in Oven- Pre-Test

Standard SPBES Module and Racking, including all power electronics. Changes to standard battery for test are as follows:

1. Added fire-rated insulation to plumbing lines.
2. Added second gasket to cooling caps.

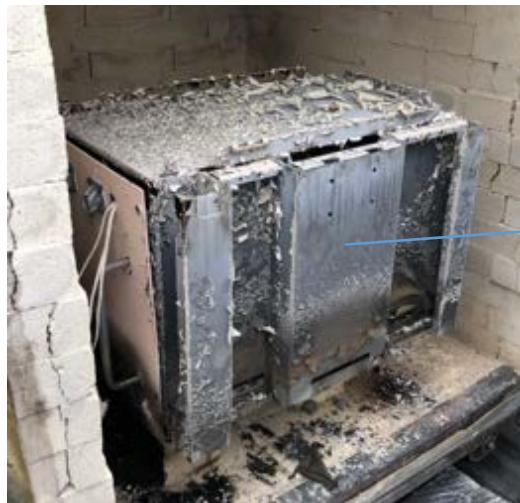
Battery on Exit of Chamber, post 950°C

This picture was taken post both A60 test 1 (survive A60 fire in an A60 room) and A60 test 2 (Battery Directly in A60 environment) and shows the impact of the high temperature on the total surfaces, note the drooping power connectors on the front of the battery. Wires are the temperature sensors throughout. All powder coating is effectively destroyed.

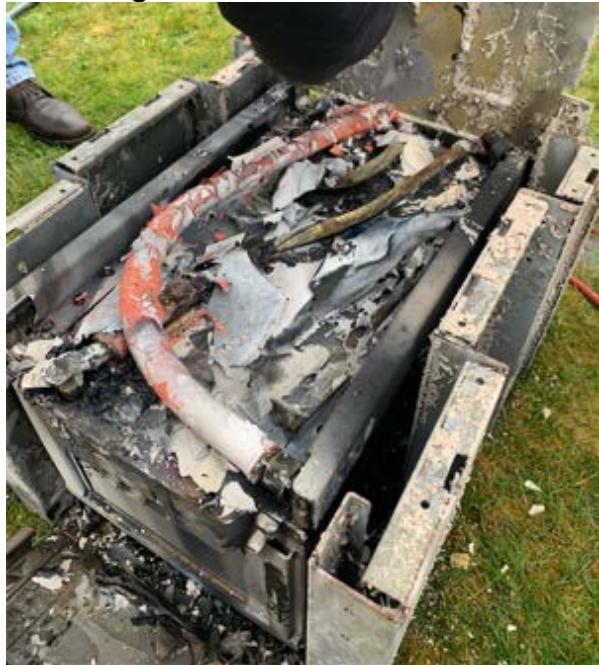
Removing Rack

Top plate removed, obvious impact of fire as everything was consumed. First indicator that the cells were intact was no obvious use of rear mounted vent, no indication of off gassing burning. All damage was obviously due to excessive heat.

Insulation added to the plumbing and wiring (test section) and was very effective in protecting components. In test one, December 13, we did not insulate the plumbing, and while it did not fail, it did start to deflect. With the insulation no deflection occurred.

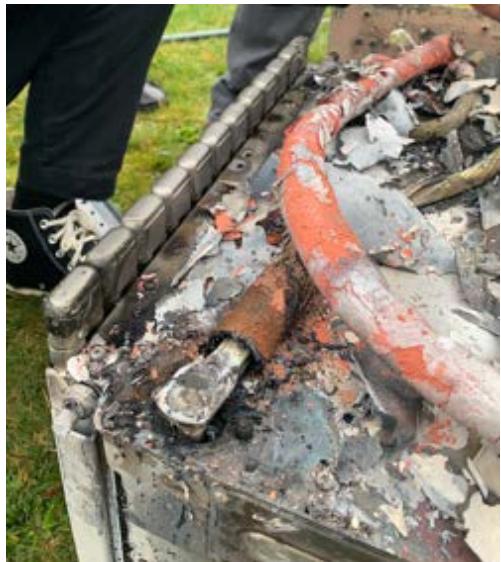
First Look- Visual Results

Cooling cap covers removed, no damage to cooling caps or watertight seals on each cell carrier. No breech of IP67 seal around the top plate.

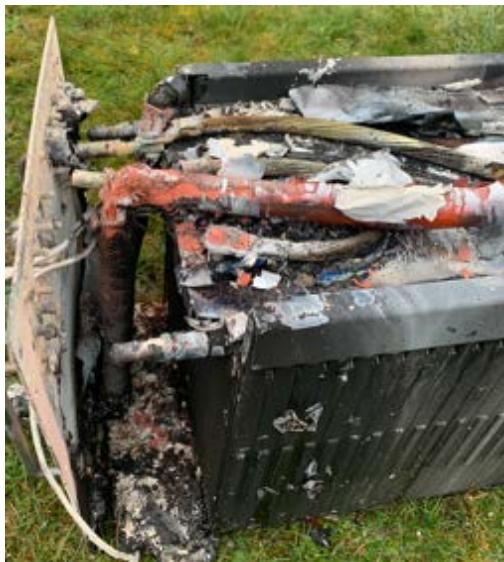
Power Ports started to melt; all of the power electronics were consumed totally. One thing we could have done better, will look to for design improvement, is to improve temperature rating effect of plastics.

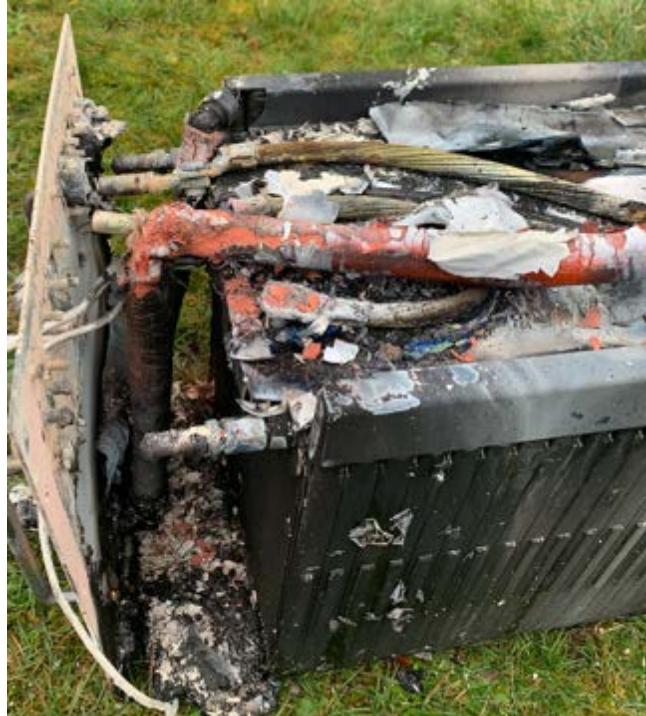
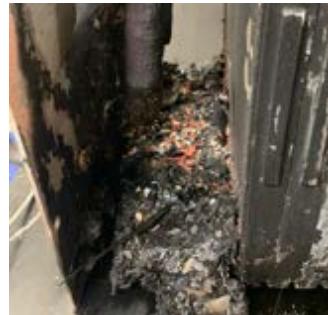
Total Destruction of the Power Electronics & PCB

Better pictures highlighting the incredible effect of high temperature fires. If not insulated, everything is consumed. Cell Carriers were totally intact, no damage at all. These cell carriers were also used in same test in December, so this is the second time they have been through this test, with no visible material damage to the cell carriers or the cooling circuit.

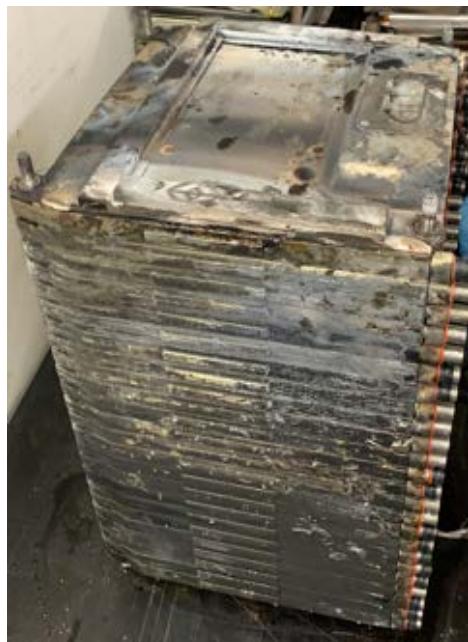
Battery Core Prior to Disassembly

Prior to disassembly following day, the cell carriers were drained of water and then disassembled. No damage to the water seals on the liquid cooling system. No damage to the crimps of the plumbing system. Only slight visible impact to the cooling caps at either end, but no damage. Cooling caps have now been used through 2 A60 Fire tests with no detrimental effect.

Vent not damaged (high temperature seal intact also) and no visual signs of cell failure.

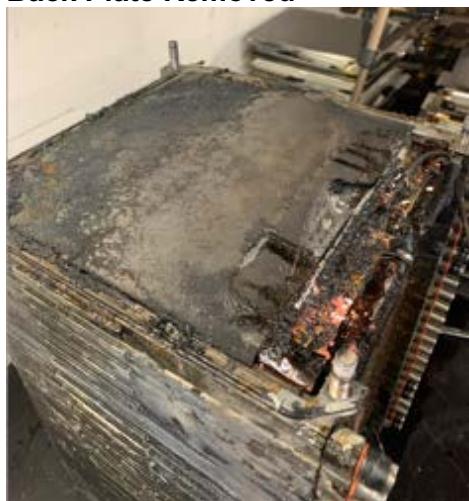
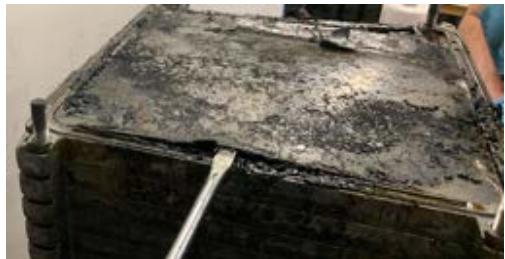
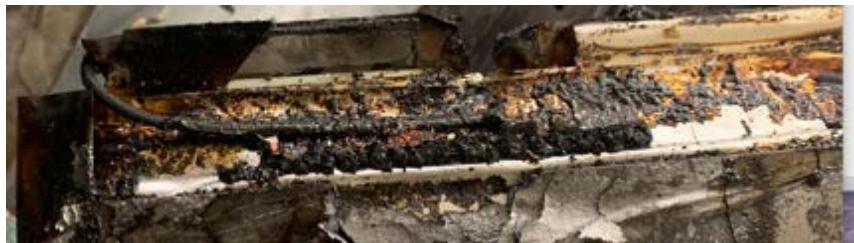
Back Plate Removed

On Removal of back plate, it was obvious that our compressive foam layer had been destroyed totally, but the graphite heat transfer sheet was totally intact, although it became more brittle than when new. The tab isolators were totally melted and probably represented the cause of the bag penetration that was evident in micro spots across the top of the cell. Interesting, the cell showed no real damage physically at all, no bloating, no sign of aggressive off gassing. It was remarkably intact. If we had a ceramic isolating insulation layer here, we think the damage of cell 24 would be the same as cell 1 and 2.

On the lower photo you can see that the temperature sensor was totally engulfed by melting plastic and this was true of cell 1 as well, so we consider the temperature readings of these cells as non-representative given the lack of physical damage to the cells.

3. Improve the battery design. The following:
 - a. A heat barrier of ceramic insulation, rated at 1200°C or better would greatly improve the effect on cell 1 and cell 24 to prevent any heat impact from the front and back faces from being impacted by the heat.

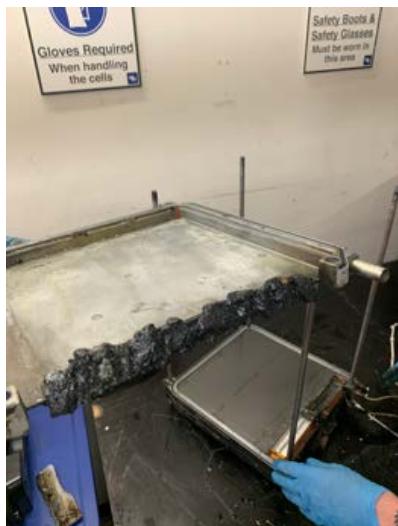
Disassembly of Stack

Both incredible evidence of the damage of a high temperature fire, and the validation of the engineering in our thermal management system.

Note the failed tab isolators, mostly melted on the side exposed to the heat, and the gasket that contains gas that survived fully intact on the outside ring- no damage at all. With the tab isolator removed, this cell carrier can be used again (it was already used in test 1 in December) and again.

- c. Consider a better way (better materials) to isolate the cell tab connectors from melting into the cell carrier space and prevent any possible failure of the cells at the cause of the melting of the cell tab connector materials.

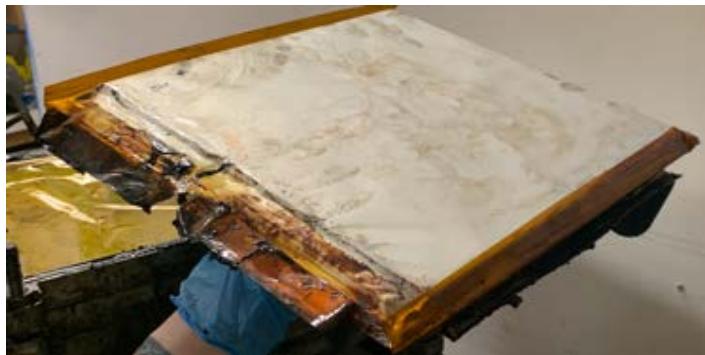
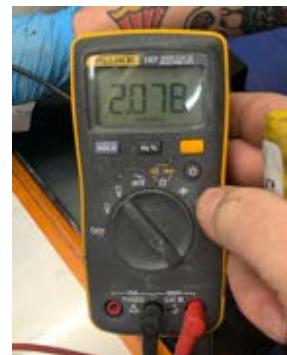
Note Cell 2 below- fully intact, graphite sheet is perfectly intact.

Cells in great shape overall. Cell 1 and Cell 24 were both "0" VDC, so totally killed, but cell 2 was holding voltage 24 hours later. We are going to test with an insulating material at the outward faces of Cell 1 and cell 24 to validate we can survive all cells with voltage.
